RE: WARNING LETTER – Non-Compliance with Industrial Stormwater General Permit #WAR003231

<h2 style="text-align: center;">STORMWATER COMPLIANCE INSPECTION REPORT</h2> <p style="text-align: center;">State of Washington Department of Ecology 3190 – 160th Avenue SE, Bellevue, WA 98008-5452</p>			WADOE Stormwater Phone: (425) 649-7000 FAX: (425) 649-7098	
Section A: General Data						
Inspection Date 2/14/2020	NPDES Permit # WAR003231	County King	Receiving Waters Duwamish River	Inspector(s) Ben Billick & Evan Dobrowski	Facility Type Industrial	
Discharges to: Surface Water <input checked="" type="checkbox"/> Ground Water <input type="checkbox"/>				ANNOUNCED Inspection		
Section B: Facility Data						
Name and Location of Site Inspected Jorgensen Forge 8531 E Marginal Way S Seattle, WA 98108		Lat & Long Latitude: 47.52652 Longitude: -122.304153		Entry Time 1310h	Permit Effective Date 01/01/2020	
				Exit Time 1500h	Permit Expiration Date 12/31/2024	
On-Site Representative(s): Name(s)/Title(s)/Contact number(s) or E-mail Wayne Turk, Environmental Project Administrator Phone: (206) 255-8177, Email: wturk@jorgensenforge.com				Additional Participants:

PHOTO ADDENDUM – JORGENSEN FORGE 2/1

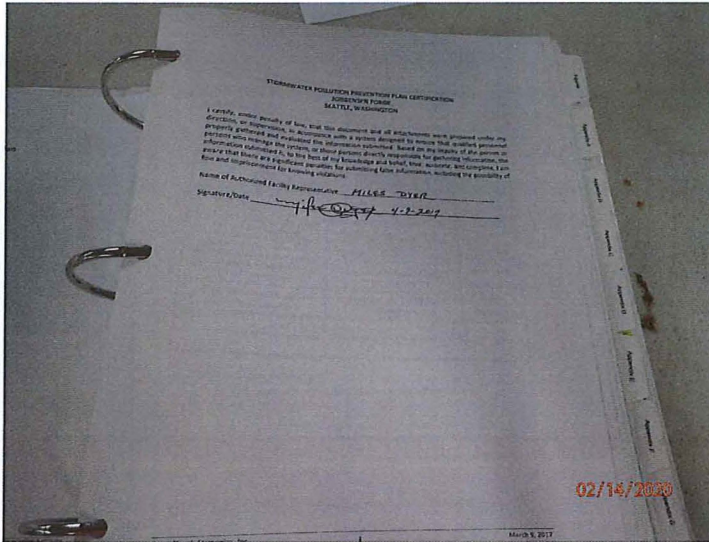
- Jorgensen Forge's SWPPP was last updated in 2017 (Photo 001), when the facility was still an operating forge. Forging operations on-site have ceased and all activities currently taking place at the property are related to demolition/abatement. The potential pollutant sources and stormwater best management practices (BMPs) associated with demolition activities are, in many cases, different than the pollutant sources and BMPs that applied to the facility when it was actively metal forging. Consequently, the SWPPP that is in use on-site does not accurately characterize current site conditions, nor does it include all appropriate BMPs. B. Billick informed W. Turk that the facility's SWPPP must be updated to reflect changes in industrial activities, potential pollutant sources, applicable BMPs, etc. B. Billick also informed W. Turk that Ecology re-issued the ISGP on January 1, 2020, and that SWPPPs for all permitted facilities were required to be updated by January 30, 2020 to comply with changes in the new permit (see ISGP condition S3.A.3.c.).

001 DESCRIPTION: JORGENSEN FORGE SWPPP SIGNATURE PAGE SHOWING THAT THE PLAN WAS LAST UPDATED IN 2017.

- In accordance with ISGP condition S3.A.3.a.ii, update the SWPPP within 30 calendar days of receipt of this report to include all applicable BMPs from the SWMM, and/or to document how selected BMPs are demonstrably equivalent to those contained in the SWMM.

- **Jorgensen Forge failed to update their SWPPP to be consistent with the 2020 ISGP by January 30, 2020, which is a violation of ISGP condition S3.A.3.c.** In accordance with ISGP condition S3.A.3.a.ii, review and

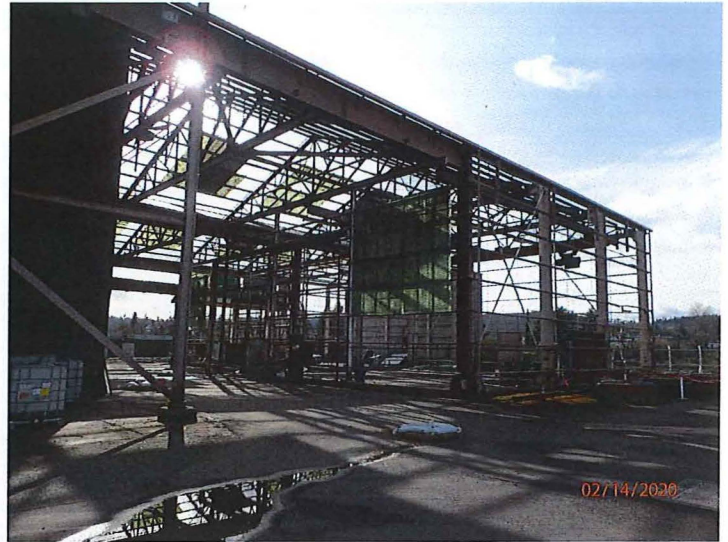
- Demolition activities have begun on multiple buildings on-site (Photos 002 - 004). Based on the condition of the buildings at the property, demolition activities completed to date appear to have included, but have not necessarily been limited to, removal of roof panels, walls, concrete flooring and/or other concrete structures, insulation, windows, doors, and interior fixtures (e.g. electrical and plumbing components). We observed standing water on the ground inside the footprint of several former buildings that have been partially demolished (Photo 005). W. Turk confirmed that this water was accumulated stormwater.

- Oil sheen on standing water within the footprint of the former melt shop warehouse (Photo 007). The area with the oil sheen was located directly beneath a ceiling-mounted lift, which may have been the source of the leak. B. Billick informed W. Turk that if the lift is identified as the source of the sheen, then the ISGP would require that containment be provided for the leak until such time as the equipment can be repaired or removed from the site. Note that the roof panels and walls have all been removed from the melt shop warehouse and the interior of this building is now exposed to precipitation (Photo 002).

002 DESCRIPTION: DEMOLITION HAS BEGUN ON THE FORMER MELT SHOP WAREHOUSE BUILDING. ROOF PANELS AND WALLS HAVE BEEN REMOVED AND INTERIOR OF BUILDING IS NOW EXPOSED TO PRECIPITATION.

- Immediately implement BMPs to minimize the exposure of pollutants in all formerly indoor areas that now have missing roof panels or walls. Ecology strongly recommends that Jorgensen Forge install temporary covers (e.g. tarps or plastic sheeting) to replace all missing roof panels and walls until such time as all waste from abatement/demolition activities are no longer located in the footprint of these former structures.

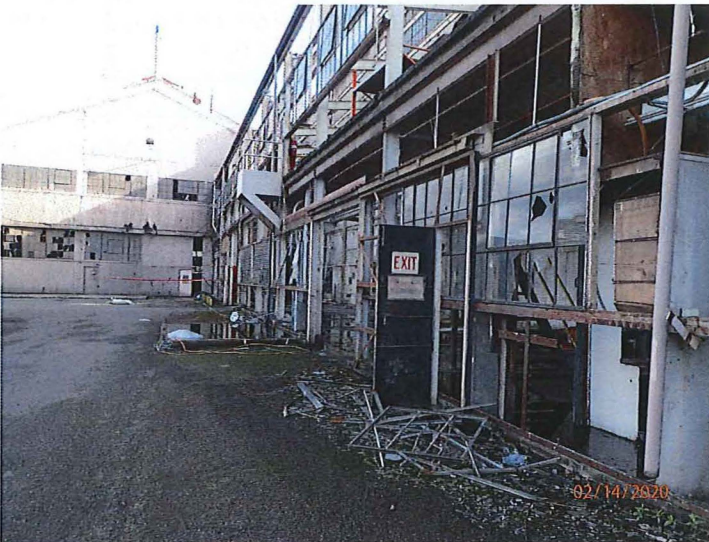
- Uncovered piles of scrap metal, glass, and other debris removed from buildings were left on the ground outdoors (Photos 003 & 019).
 - Components from the facility's electrical system were left on the ground outdoors (Photo 020).

003 DESCRIPTION: DEMOLITION HAS BEGUN ON MULTIPLE BUILDINGS ON-SITE. PHOTOS SHOWS BUILDING WITH SOME WALLS, INSULATION, AND WINDOWS REMOVED. DEBRIS FROM DEMOLITION PILED ON GROUND ADJACENT TO BUILDING.

- **Jorgensen Forge failed to implement adequate housekeeping BMPs for ongoing maintenance and cleanup of areas which may contribute pollutants to stormwater discharges, which is a violation of ISGP condition S3.B.4.b.i.2.** Immediately implement improved BMPs for the cleanup and removal of debris in all areas exposed to precipitation, including areas inside buildings that are now exposed to precipitation. This includes cleanup and removal of paint chips, loose paint on surfaces exposed to precipitation, insulation debris, metal particulates, broken portions of walls and roof panels, etc.

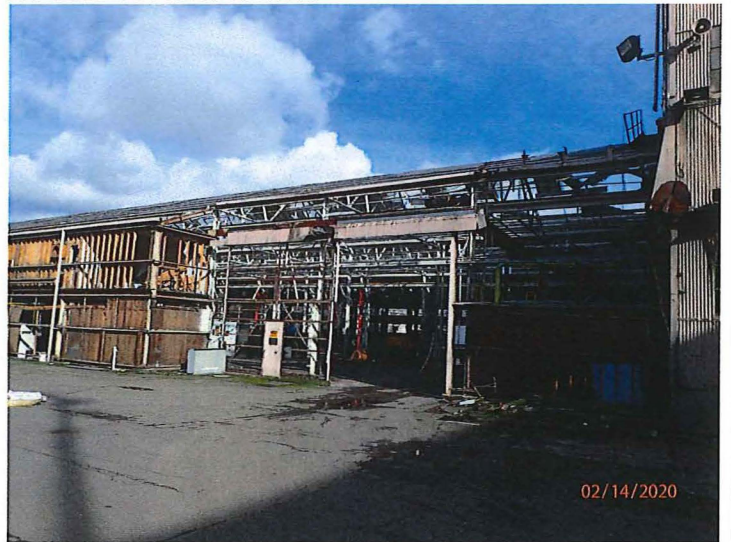
004 DESCRIPTION: DEMOLITION HAS BEGUN ON MULTIPLE BUILDINGS ON-SITE. PHOTO SHOWS BUILDING WITH ROOF PANELS, WALLS, INSULATION, WINDOWS, AND DOORS REMOVED. INTERIOR OF BUILDING IS NOW EXPOSED TO PRECIPITATION.

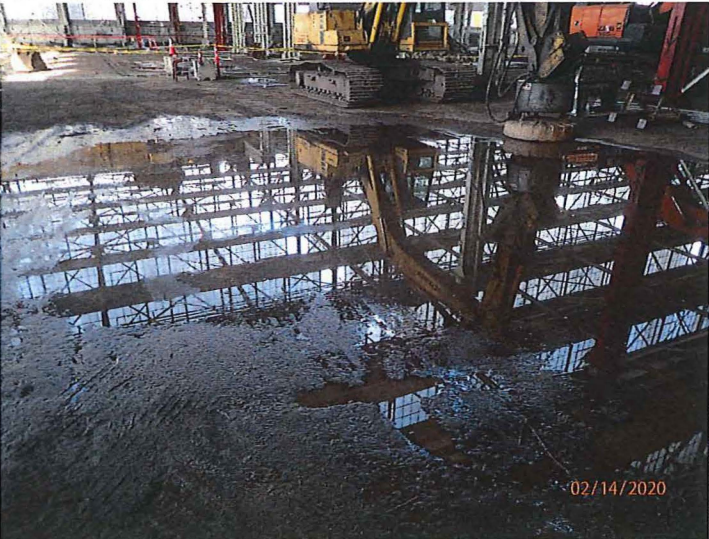
005 DESCRIPTION: ACCUMULATED STORMWATER ON GROUND INSIDE OF BUILDING. THE GROUND IN THIS AREA IS COVERED IN "PROCESS WASTE" THAT DESIGNATES AS A DANGEROUS WASTE.

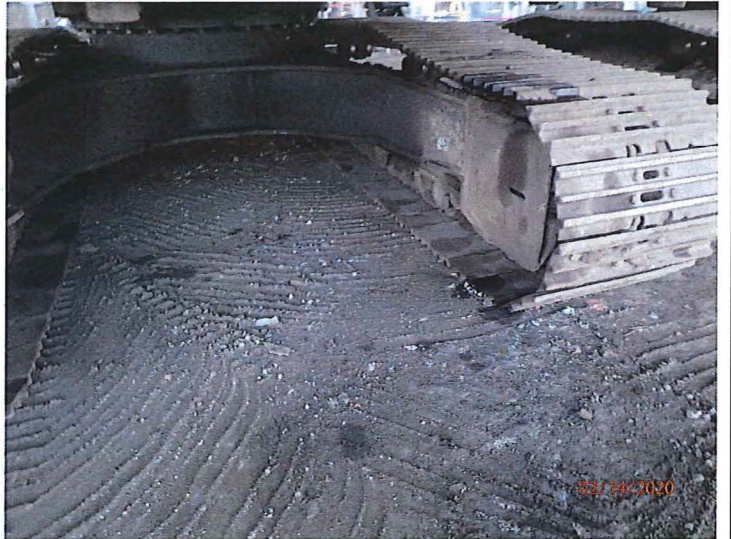
- Exposed soils are present inside multiple buildings on-site. Additionally, surfaces throughout the interior of much of the facility are coated in a layer of fine dust that the facility refers to as "process waste" (Photo 006). Katy Harvey with Ecology's Hazardous Waste Program has informed B. Billick that this "process waste" designates as a Washington State dangerous waste. Because roof panels and walls have been removed from several buildings on-site, some areas containing "process waste" and exposed soil are now exposed to precipitation and have the potential to contaminate stormwater. The ISGP requires that secondary containment be provided for "all hazardous substances, petroleum/oil liquids, and other chemical solid or liquid materials that have the potential to contaminate stormwater." The soils on-site are known to be contaminated and the "process waste" designates as a dangerous waste, which means that Jorgensen Forge is required to provide secondary containment for any areas where potentially contaminated soils or "process waste" are exposed to precipitation or otherwise have the potential to contaminate stormwater runoff.

006 DESCRIPTION: DUST ON GROUND INSIDE OF BUILDINGS IS "PROCESS WASTE" THAT DESIGNATES AS A DANGEROUS WASTE.

- **Jorgensen Forge failed to identify and control all sources of dust (e.g. "process waste" dust) to minimize stormwater contamination from the deposition of dust on areas exposed to precipitation. This is a violation of ISGP condition S3.B.4.b.i.2.b.** Immediately implement improved BMPs to control dust and prevent the exposure of dust to precipitation. Due to the removal of roof panels and walls from several buildings, Jorgensen Forge has exposed "process waste" dust in many areas to precipitation. Ecology's recommended BMP for addressing this violation and complying with the ISGP is to install temporary covers (e.g. tarps or plastic sheeting) to replace all missing roof panels and walls until such time as all waste from abatement/demolition activities are no longer located in the footprint of these former structures.

- Please note that the secondary containment requirement applies to areas which contain "process waste" dust that could potentially contaminate stormwater. If full secondary containment cannot be provided for areas with "process waste" dust, than Jorgensen Forge should eliminate all potential stormwater exposure for these areas. This can be accomplished by installing temporary cover on all open roofs and walls along with improved BMPs to prevent track out from areas containing "process waste."

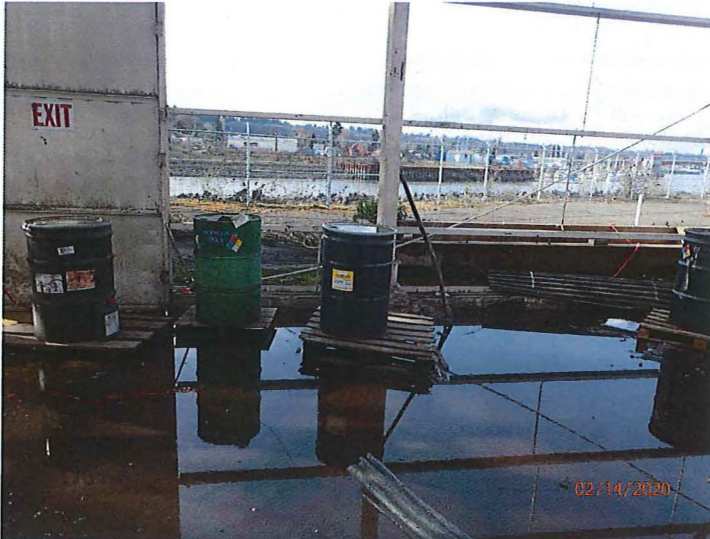
007 **DESCRIPTION:** MULTIPLE 55-GALLON DRUMS WITHOUT SECONDARY CONTAINMENT INSIDE THE FOOTPRINT OF THE FORMER MELT SHOP WAREHOUSE BUILDING. TWO DRUMS SHOWN WERE LABELED AS DANGEROUS WASTE, ONE DRUM WAS LABELED AS ANTIFREEZE THOUGH W. TURK STATED THAT THIS LABEL WAS INCORRECT. OIL SHEEN PRESENT ON THE STANDING WATER ON THE GROUND INSIDE THIS BUILDING.

- **Jorgensen Forge failed to provide secondary containment for all hazardous substances, petroleum/oil liquids, and other chemical solid or liquid materials that have the potential to contaminate stormwater, which is a violation of ISGP condition S3.B.4.b.i.4.a.** Secondary containment means storing hazardous substances on an impervious surface that is surrounded with a containment berm or dike that is capable of containing 10% of the total enclosed tank volume or 110% of the volume contained in the largest tank, whichever is greater, or use double-walled tanks. Immediately provide secondary containment for all potentially hazardous substances in areas of the site with potential stormwater exposure (including indoor areas where hazardous substances could make it outdoors through track out and/or as the result of a spill).

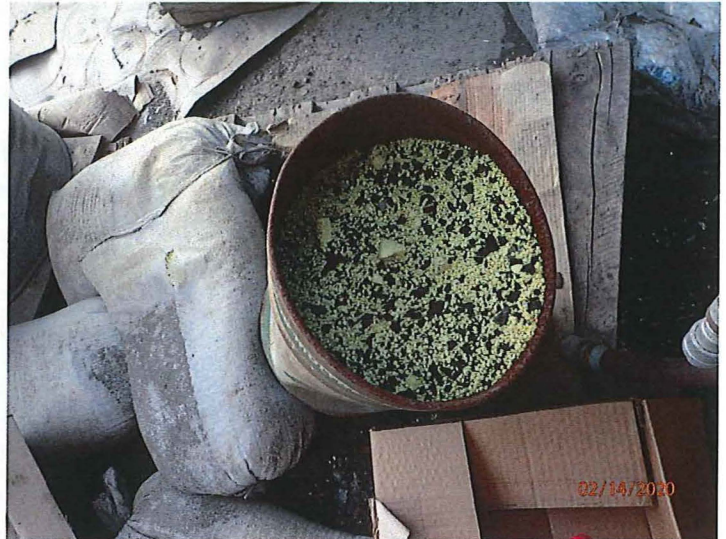
008 **DESCRIPTION:** UNCOVERED BUCKET WITHOUT SECONDARY CONTAINMENT HOLDING UNIDENTIFIED YELLOW AND BLACK CHEMICAL SOLIDS. THE SANDBAGS ON THE LEFT SIDE OF THE BUCKET ALSO HELD THE YELLOW CHEMICAL SOLIDS. W. TURK STATED THAT HE THOUGHT THE YELLOW CHEMICAL SOLIDS MIGHT BE SULFUR, BUT WAS UNSURE ABOUT THE BLACK CHEMICAL SOLIDS.

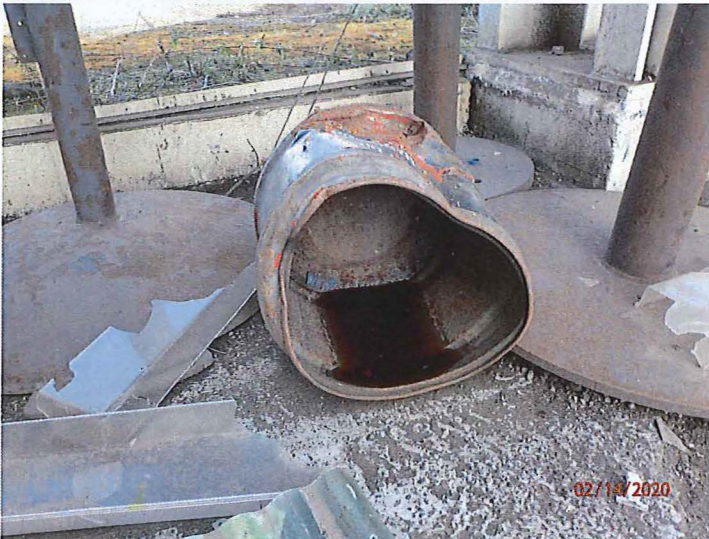
009 **DESCRIPTION:** OPEN BUCKET WITH AN OILY LIQUID LAYING ON ITS SIDE. BUCKET EXPOSED TO STORMWATER WITH NO SECONDARY CONTAINMENT.

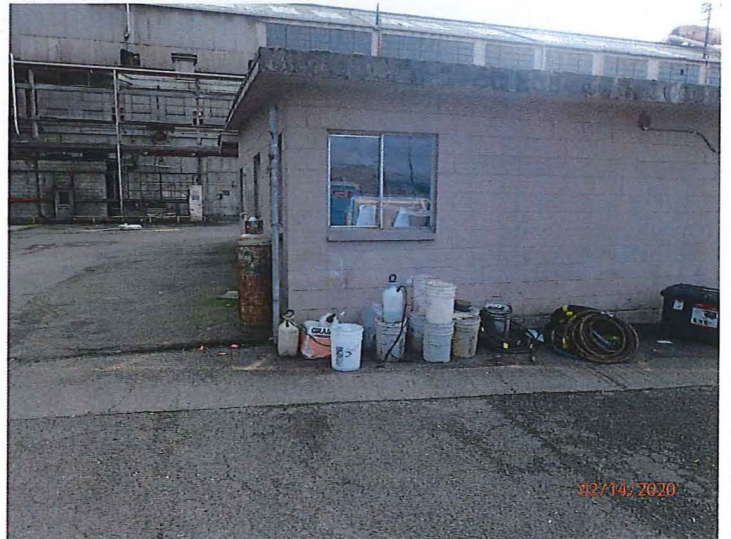
010 **DESCRIPTION:** MULTIPLE 5-GALLON BUCKETS AND LIQUID CHEMICAL SPRAY APPLICATORS SITTING OUTSIDE WITHOUT SECONDARY CONTAINMENT.

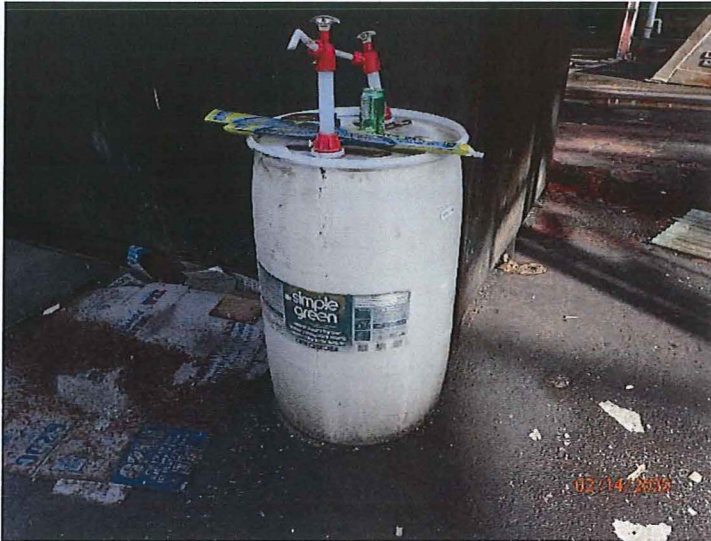
011 DESCRIPTION: 55-GALLON DRUM OF SIMPLE GREEN WITHOUT SECONDARY CONTAINMENT INSIDE THE FOOTPRINT OF A FORMER BUILDING WITH MISSING ROOF PANELS.

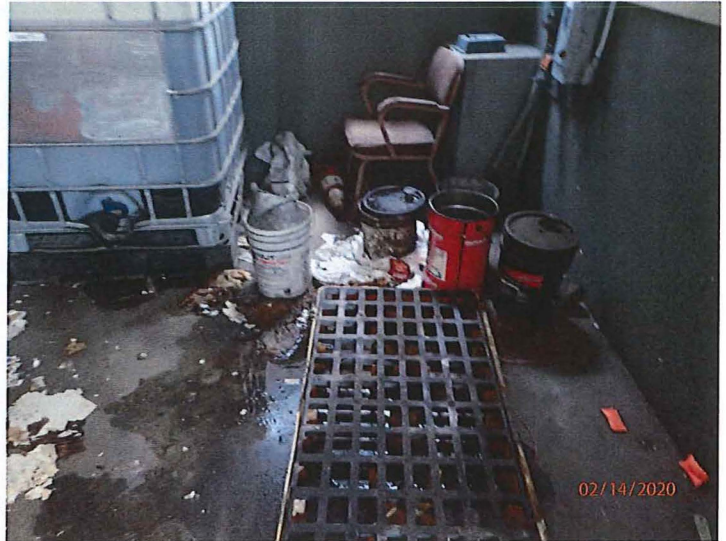
- Unused secondary containment pallets and trays were observed in multiple locations on-site (Photos 012 - 014). B. Billick informed W. Turk that these BMPs should be used for storing the various chemical containers on-site that did not have secondary containment. Two secondary containment devices inside footprint the former melt shop warehouse, which is missing its roof and walls, held accumulated stormwater with visible oil sheen and chemical

012 DESCRIPTION: 5-GALLON BUCKETS AND 250-GALLON TOTES OF MISCELLANEOUS CHEMICALS AND PETROLEUM PRODUCTS WITHOUT SECONDARY CONTAINMENT INSIDE LABORATORY BUILDING. SPILLS ON GROUND THROUGHOUT THIS ROOM. THOUGH THESE CHEMICALS ARE INDOORS, CONTAINMENT SHOULD STILL BE PROVIDED DUE TO THE POTENTIAL FOR SPILLS THAT COULD MAKE IT OUTSIDE. UNUSED SECONDARY CONTAINMENT PALLET IN FOREGROUND.

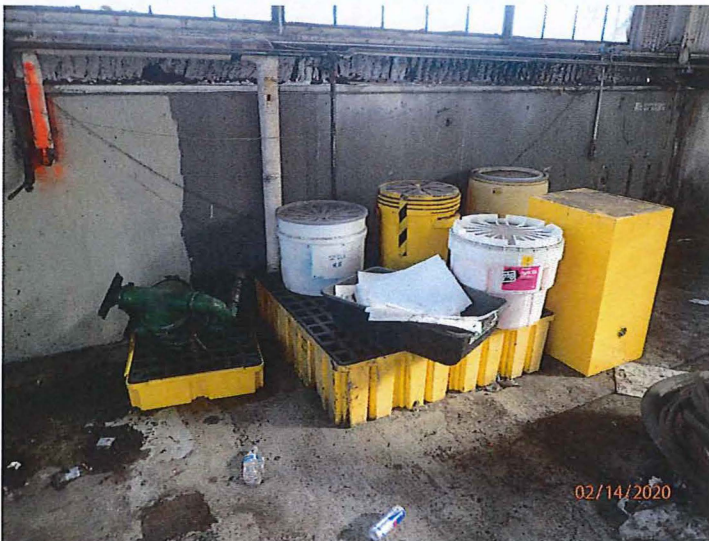
- Spill kits were present on-site, but they were not well distributed throughout the property. The majority of the spill kits that we observed were located inside of the aluminum heat treat building on the east side of the site (Photo 013). Storing the majority of the spill kits in this single location makes it more difficult for facility personnel to respond immediately in the event of a leak or spill, as required by the ISGP.

013 DESCRIPTION: UNUSED SECONDARY CONTAINMENT PALLETS INSIDE ALUMINUM HEAT TREAT BUILDING. THE CONTAINERS ON TOP OF THE PALLET ARE SPILL KITS WHICH WERE CONCENTRATED IN THIS BUILDING. ECOLOGY RECOMMENDS DISTRIBUTING SPILL KITS THROUGHOUT THE SITE TO FACILITATE SPILL CLEANUP ACTIVITIES.

- **Jorgensen Forge failed to clean up all spills and leaks immediately to prevent the discharge of pollutants, which is a violation of ISGP condition S3.B.4.b.i.3.d.** Ensure that all leaks and spills of liquid or solid chemical and petroleum products are cleaned up immediately. In order to facilitate immediate leak/spill cleanup, Ecology strongly recommends that Jorgensen Forge begin regularly inspecting the site for housekeeping issues. Ecology also recommends that Jorgensen Forge distribute spill kits throughout the site and inform all on-site personnel of the spill kit storage locations and the facility's spill response procedures.

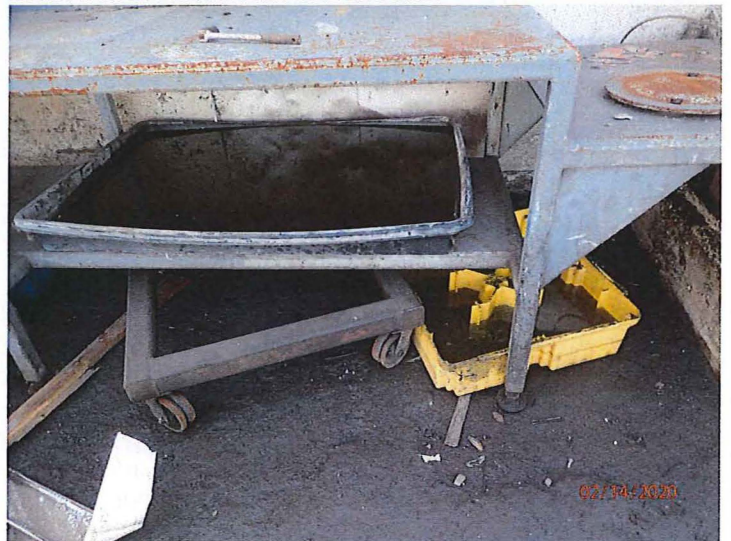
residue (Photo 014). One of the two secondary containment devices was filled to the brim and may have overflowed onto the ground, which was wet in the surrounding area. B. Billick informed W. Turk that the accumulated water in these secondary containment devices must be properly disposed of, and could not be allowed to discharge off-site, to the storm system, or to surface waters.

014 DESCRIPTION: TWO UNUSED SECONDARY CONTAINMENT TRAYS IN THE MELT SHOP WAREHOUSE BUILDING THAT WERE FILLING UP WITH STORMWATER WHICH HAD EVIDENCE OF SHEEN AND CHEMICAL RESIDUE. BLACK TRAY WAS FILLED TO THE BRIM WITH ACCUMULATED STORMWATER AND MAY HAVE OVERFLOWED. THIS WATER CANNOT BE ALLOWED TO DISCHARGE OFF-SITE TO THE STORM SYSTEM, OR TO SURFACE WATERS.

- Immediately ensure that containment areas are covered and/or that procedures are implemented to properly manage and dispose of any water that accumulates in containment areas.

- Properly dispose of accumulated water inside the secondary containment trays in the melt shop warehouse. This water cannot be allowed to discharge off-site, to the storm system, or to surface waters.

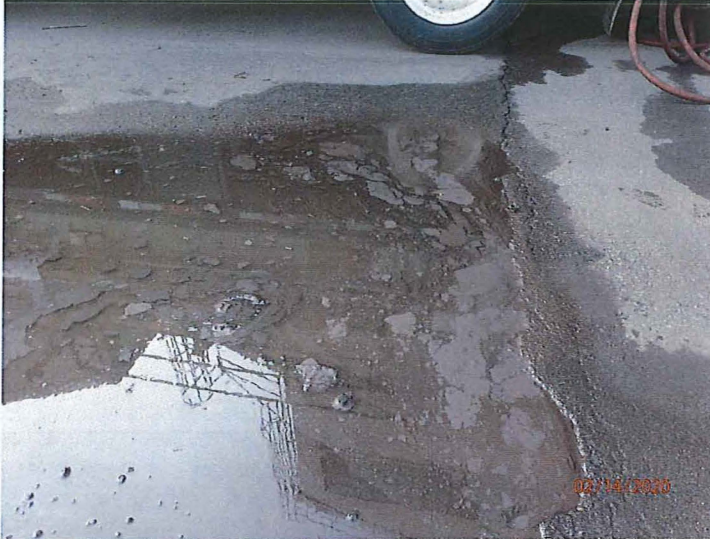
- An unidentified chemical film was observed on top of standing water in two locations on-site exposed to rainfall: 1) near the old transformer pad in the outdoor yard that occupies the northwestern portion of the facility, and 2) on the east side of the forge shop area near the aluminum heat treat building (Photo 015). The water with the chemical film near the heat treat building was located up gradient of a catch basin, and we observed staining on the ground that indicated water from the puddle with the chemical film had discharged to the catch basin (Photo 016).

015 DESCRIPTION: UNIDENTIFIED CHEMICAL FILM ON TOP OF STANDING WATER ON WEST SIDE OF SITE NEAR THE ALUMINUM HEAT TREAT BUILDING. NOTE WATER STAINING ON PAVEMENT FROM PUDDLE TOWARD VEHICLE TIRE IN BACKGROUND.

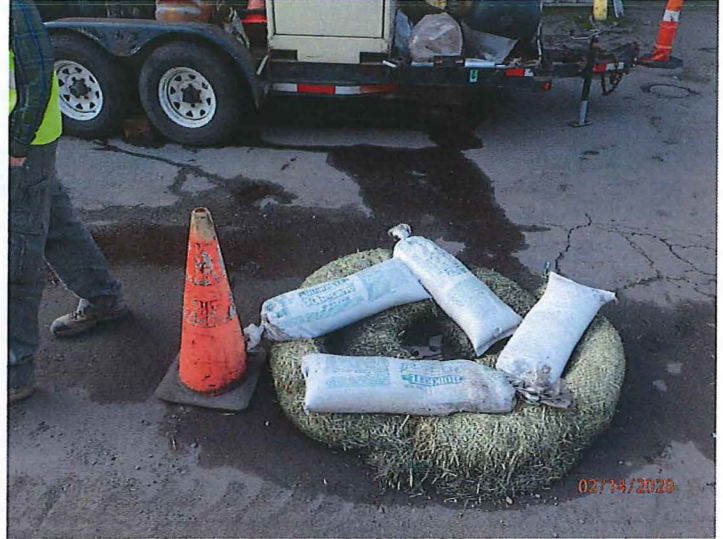
016 DESCRIPTION: CATCH BASIN ON THE OPPOSITE SIDE OF THE VEHICLE WITH TIRE SHOWN IN PHOTO 015. NOTE WATER STAINING LEADING FROM THE VEHICLE TO THE CATCH BASIN. THIS IS EVIDENCE THAT THE STANDING WATER WITH THE CHEMICAL FILM HAS DISCHARGED TO THE SITE STORM SYSTEM.

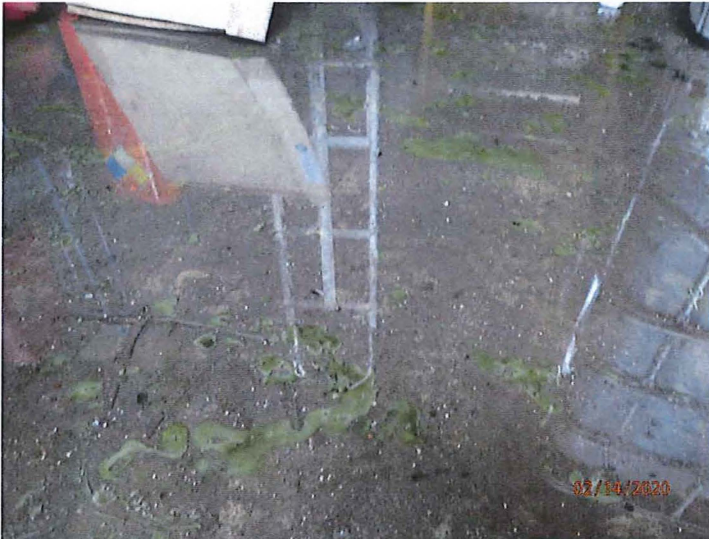
- Multiple spills were observed inside of the laboratory building, which was being used to hold a number of chemical containers that were mostly stored outside of secondary containment. Spills included puddles and staining from petroleum products, and a yellow/green oily substance that we observed on top of standing water directly inside of the door to the laboratory building (Photos 012 & 017). Though these chemicals and the associated spills were all located inside of the laboratory building, which had not yet been demolished, there is still the potential for spilled material to migrate outside (as track out on employee footwear, for example).

017 DESCRIPTION: UNIDENTIFIED CHEMICAL SPILL INSIDE OF THE LABORATORY BUILDING. SPILLED CHEMICALS COULD MAKE IT OUTSIDE AS A RESULT OF TRACK OUT ON FOOTWEAR.

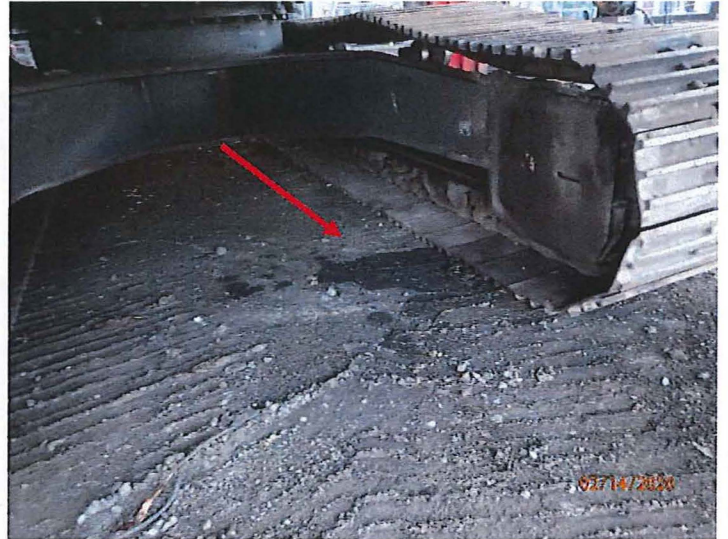
- Two of the excavators with potential exposure to precipitation were actively leaking onto the ground (Photo 018).
- Waste debris from demolition activities was not being stored in a manner that minimizes exposure to precipitation and reduces the potential for contamination of stormwater runoff. Issues related to waste storage and handling on-site included, but were not necessarily limited to, the following:

018 DESCRIPTION: STAINING ON GROUND FROM LEAKING EXCAVATOR (RED ARROW).

- **Jorgensen Forge failed to use drip pans and absorbents under or around leaky vehicles and equipment on-site, which is a violation of ISGP condition S3.B.4.b.i.4.h.** Immediately provide drip pans, absorbents, or equivalent containment for all leaking vehicles and equipment on-site. This applies to leaking vehicles in any portion of the site with exposure to precipitation, including inside of buildings with missing roof panels or walls.

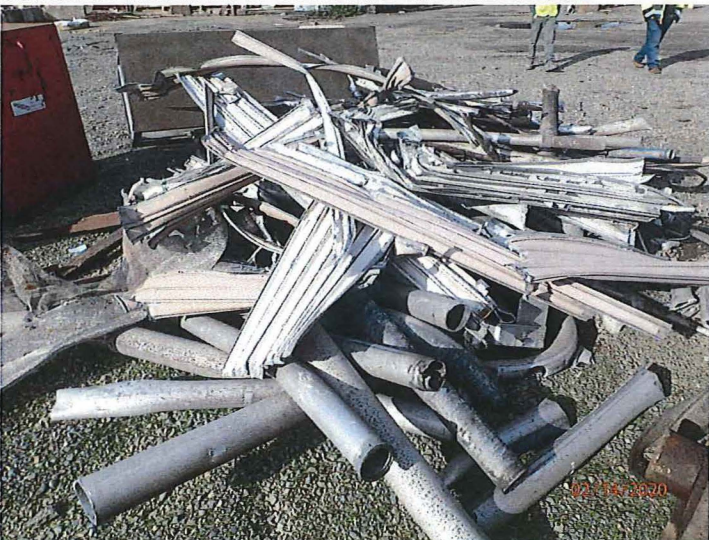
019 DESCRIPTION: PILE OF SCRAP METAL LEFT ON THE GROUND OUTSIDE.

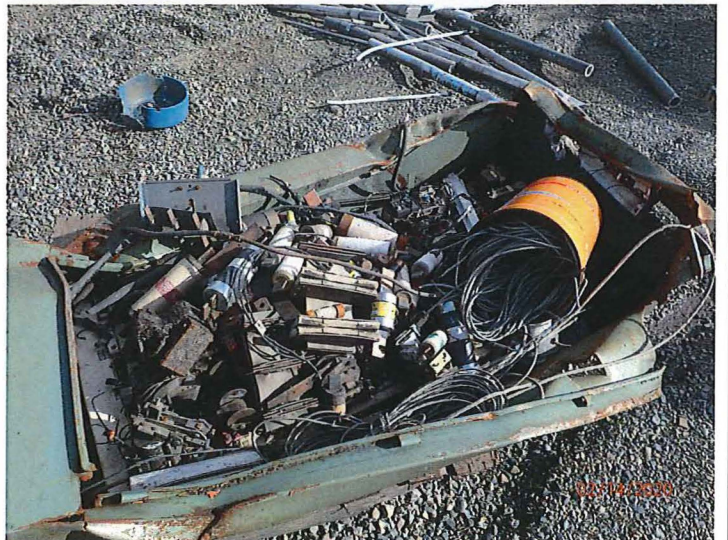
020 DESCRIPTION: COMPONENTS FROM THE FACILITY'S ELECTRICAL SYSTEM LEFT ON THE GROUND OUTSIDE.

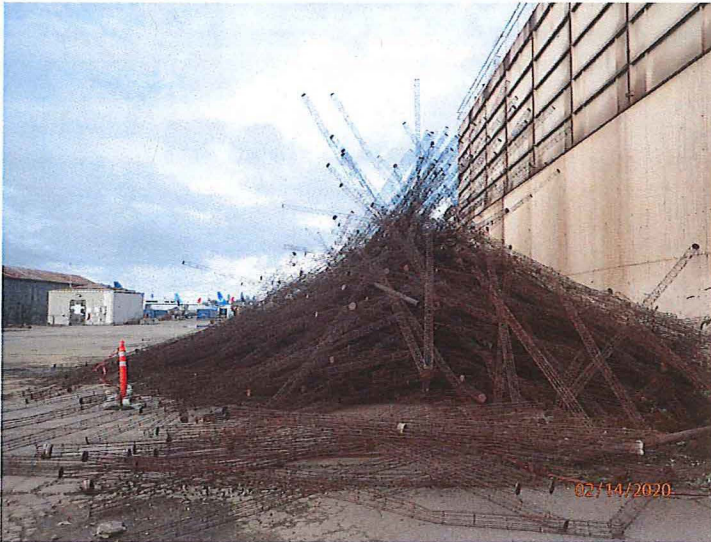
- A large pile of wire frames was on the ground outdoors (Photo 021). These wire frames previously held the air filters in the melt shop baghouse, and could potentially contain residual chemicals from when they were used inside of the baghouse.

021 DESCRIPTION: PILE OF WIRE FRAMES THAT PREVIOUSLY HELD AIR FILTERS IN THE MELT SHOP BAGHOUSE LEFT ON THE GROUND OUTSIDE.

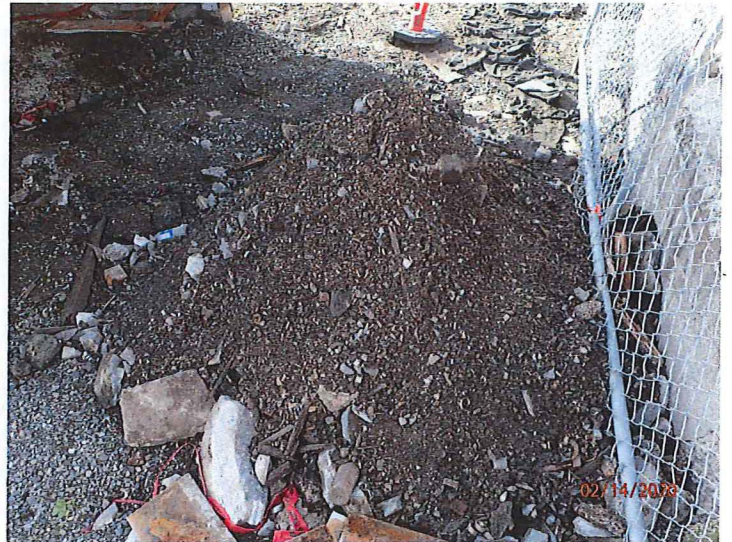
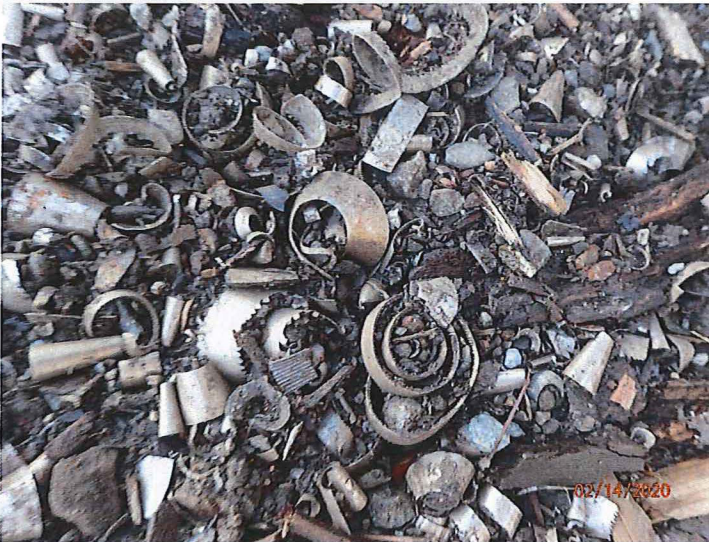
- Piles of metal turnings mixed with soil/debris that appeared to contain an oily residue were left on the ground outdoors (Photos 022 & 023).
 - Multiple dumpsters on-site were uncovered, despite not actively being used at the time of the inspection. One uncovered dumpster contained galbestos siding, plastic sheeting used as containment during demolition activities, and an unidentified dark grey dust that resembled the "process waste" that is spread throughout the interior of the buildings (Photo 024 & 25). We observed water leaking from the back of this dumpster onto the ground (Photo 026).

022 DESCRIPTION: PILE OF METAL TURNINGS MIXED WITH SOIL/DEBRIS THAT APPEARED TO CONTAIN OILY RESIDUE LEFT ON THE GROUND OUTSIDE.

023 DESCRIPTION: CLOSE UP OF THE PILE OF METAL TURNINGS AND SOIL/DEBRIS FROM PHOTO 022.

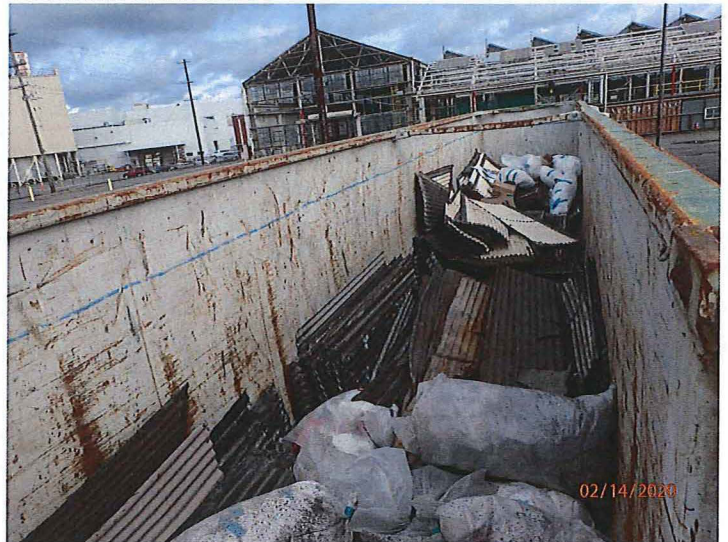
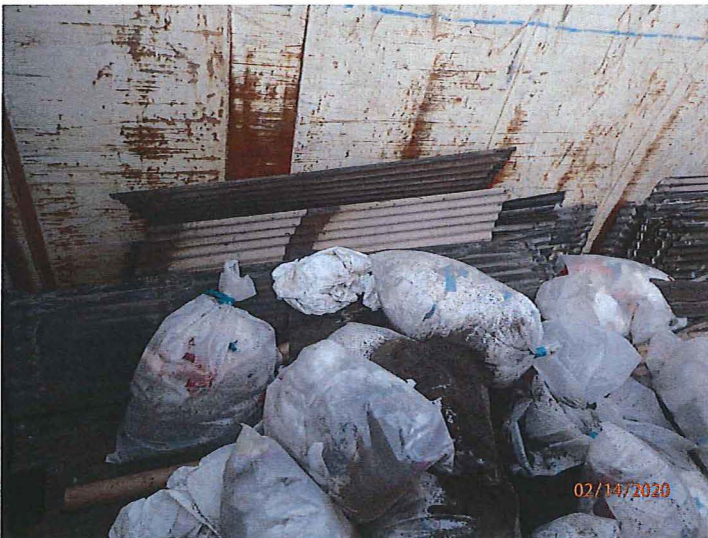
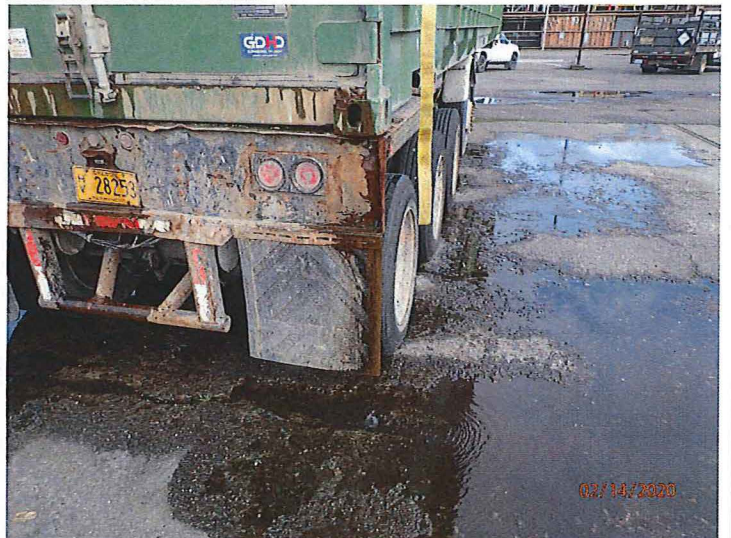
024 DESCRIPTION: UNCOVERED DUMPSTER WITH GALBESTOS SIDING AND PLASTIC SHEETING USED AS CONTAINMENT DURING DEMOLITION ACTIVITIES.

025 DESCRIPTION: UNIDENTIFIED GRAY DUST THAT RESEMBLED THE "PROCESS WASTE" INSIDE UNCOVERED DUMPSTER.

026 DESCRIPTION: WATER WAS LEAKING FROM THE BACK OF THE UNCOVERED DUMPSTER SHOWN IN PHOTOS 024 & 025 DURING THE INSPECTION.

- **Jorgensen Forge failed to keep all dumpsters under cover or fit with a storm resistant lid that must remain closed when not in use, which is a violation of ISGP condition S3.B.4.b.i.2.d.** Immediately ensure that all dumpsters on-site are stored under cover or fit with a lid that is kept closed when not in use.

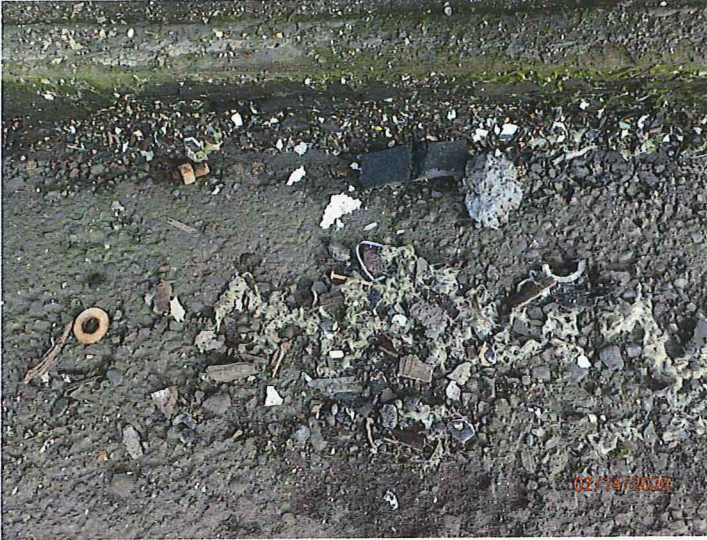
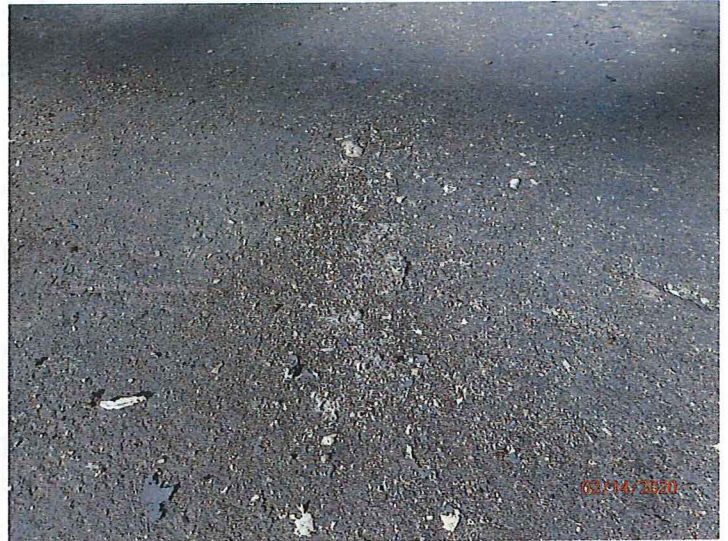
- Particulate debris from demolition activities was observed on the ground exposed to precipitation, both inside and outside of the facility (Photos 027 & 028). Particulate debris observed in areas exposed to precipitation included, but was not necessarily limited to, paint chips, insulation, and pieces of miscellaneous metal (note that the exposed "process waste" is not included in this list because it is discussed elsewhere in the report).

027 **DESCRIPTION:** PARTICULATE DEBRIS INCLUDING PAINT CHIPS, INSULATION, AND METAL FRAGMENTS ON THE GROUND OUTSIDE.

028 **DESCRIPTION:** PAINT CHIPS ON THE GROUND IN THE FOOTPRINT OF A FORMER BUILDING THAT HAS HAD ROOF PANELS AND WALLS REMOVED AND IS NOW EXPOSED TO PRECIPITATION.

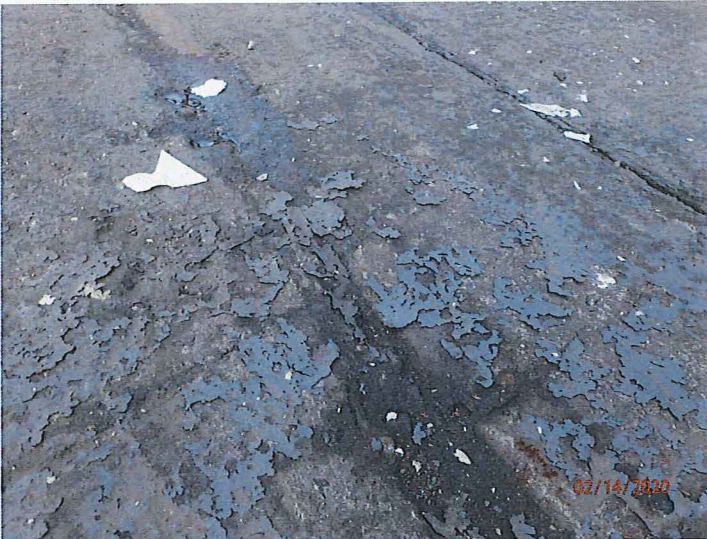
- The floor of one former building that has had the roof panels and walls removed was previously painted. The paint coat on the floor has degraded and the paint was flaking off (Photo 029). This chipping paint has the potential to contaminate stormwater and could also be tracked to other areas of the facility by vehicles and equipment.

029 **DESCRIPTION:** PAINT FLAKING OFF OF THE FLOOR IN THE FOOTPRINT OF A FORMER BUILDING THAT HAS HAD ROOF PANELS AND WALLS REMOVED AND IS NOW EXPOSED TO PRECIPITATION.

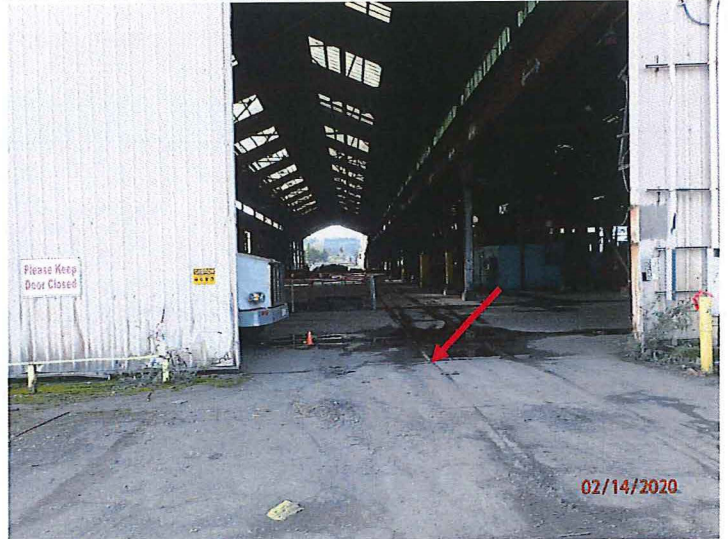
- Vehicles/equipment and personnel exiting the buildings and the footprints of former buildings have the potential to track out contaminated soil or "process waste." No BMPs were installed to prevent track out from the buildings on vehicle/equipment tires or employee footwear. Evidence of potential track out was observed in at least one location (Photo 030).

030 **DESCRIPTION:** NO TRACK OUT CONTROL BMPs AT EXIT FROM BUILDING. TIRE TRACKS (RED ARROW) OUTSIDE BUILDING, POTENTIALLY AS A RESULT OF TRACK OUT OF MATERIALS FROM INSIDE.

- Implement BMPs to control track out of soil or "process waste" at all locations where vehicles, equipment, or personnel exit the buildings on-site. This includes BMPs to address track out on both vehicle/equipment tires and on employee footwear. BMPs may be structural (e.g. rumble plates for vehicle/equipment tires) and/or operational (e.g. requiring employees to wear covers over their shoes that can be removed upon exiting the buildings).

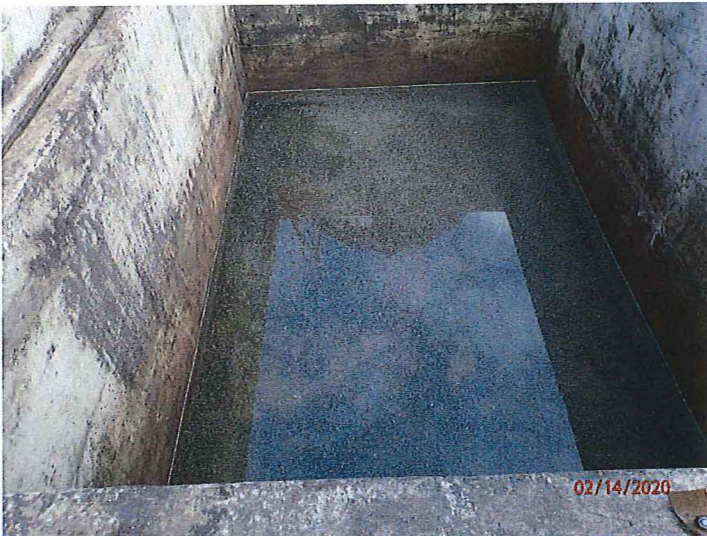
- One of the pits in the decommissioned oil storage area on the east side of the site was uncovered and accumulating stormwater. Unidentified white particles were floating on top of the accumulated water (Photo 031). B. Billick recommended to W. Turk that the facility cover this pit to prevent additional stormwater accumulation. B. Billick informed W. Turk that this water is not permitted to be discharged to the storm system, and will either need to be hauled off-site for disposal or discharged to sanitary sewer with approval of the local sewer authority. By leaving the pit uncovered, Jorgensen Forge is creating the potential for additional stormwater accumulation, which will likely increase the cost of disposal.

031 **DESCRIPTION:** STANDING WATER WITH UNIDENTIFIED WHITE PARTICLES IN PIT AT FORMER OIL STORAGE AREAS. WATER CANNOT BE ALLOWED TO DISCHARGE TO STORM SYSTEM OR SURFACE WATERS.
